2.0 Burrell, Pennsylvania, Disposal Site

2.1 Compliance Summary

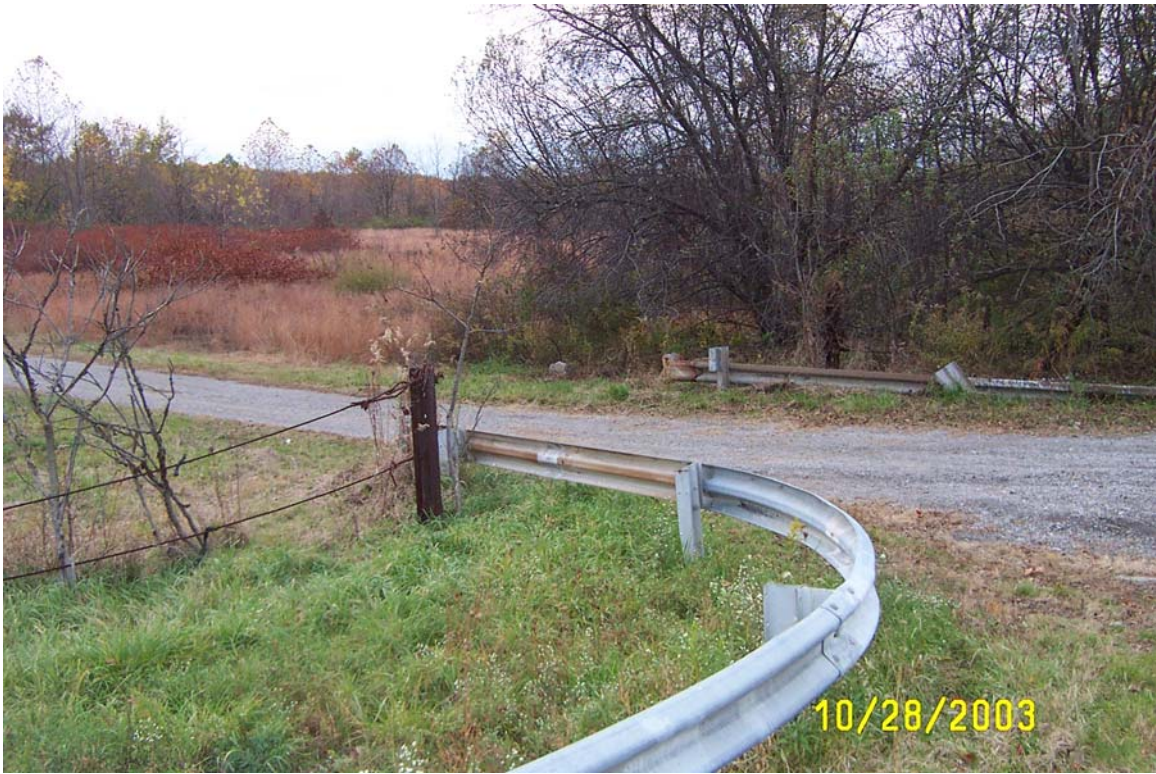
Site Access, Fence, Gates, and Signs—An access road leads from Strangford Road to the security fence at the site boundary. The former access gate at Strangford Road was unsuccessful in keeping people off the access road and out of the areas adjacent to the site, and was open and heavily damaged at the time of the 2002 inspection. DOE determined that limiting site access at Strangford Road did not enhance site security or protectiveness, and received concurrence from the U.S. Nuclear Regulatory Commission on April 28, 2003, to remove the gate. The gate was removed prior to the 2003 inspection (PL-1). The hard-packed graveled access road runs southwest across DOE's perpetual right-of-way (Tract 201-E) and DOE's leased crossing over Norfolk Southern Railroad right-of-way to the site. There were shallow potholes in the road but it was easily passable in a passenger car.

BUR 10/2003. PL-1. Location of the former access gate at Strangford Road.

In 2003, DOE removed the Strangford Road access gate and cleared vegetation from fence lines and monitor well access routes.

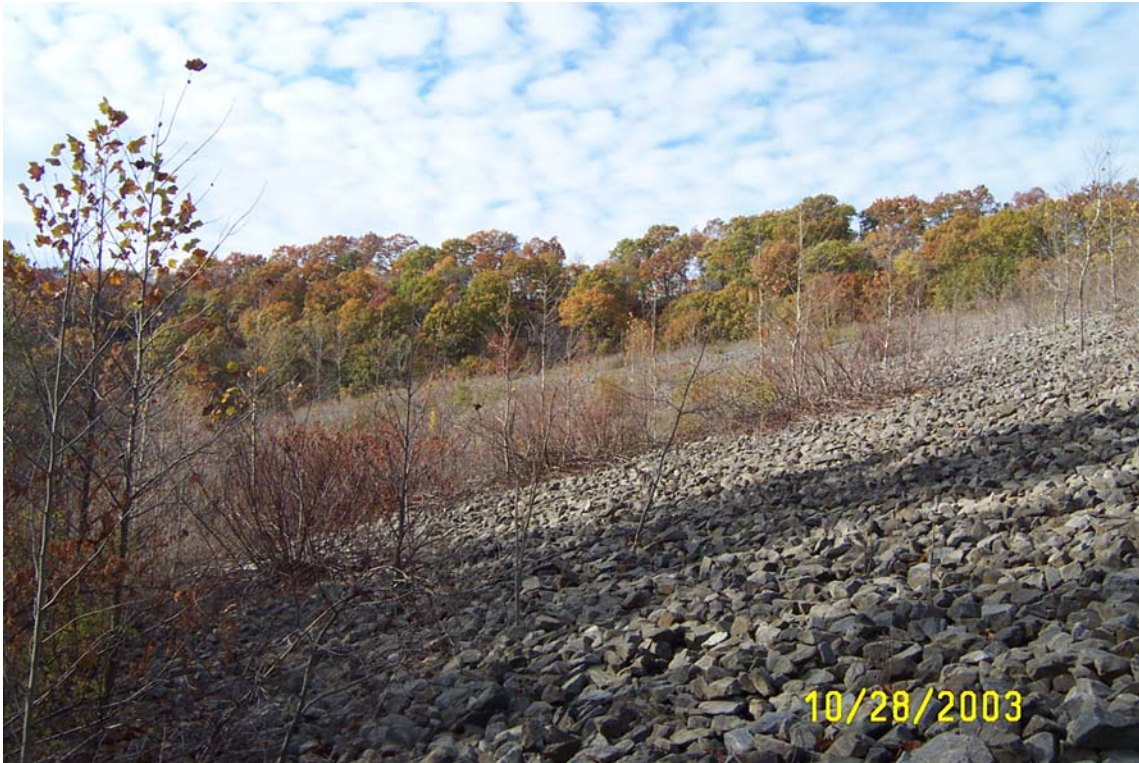
Trees and shrubs continue to establish in the riprap (PL-2). In the past, this vegetation was aggressively controlled with massive applications of herbicide. A study that evaluated risks posed by encroachment of plants on the disposal cell demonstrated that the plants will not degrade the long-term performance of the cell and may improve performance by reducing moisture in the cover through evapotranspiration.

The revised Long-Term Surveillance Plan allows the vegetation to grow on the disposal cell without further intervention; such growth will not increase risk to public health, safety, or the environment. In their concurrence in the revised Long-Term Surveillance Plan, the U.S. Nuclear Regulatory Commission suggested that DOE reevaluate the effects of vegetation on cover performance in 10 or 20 years to confirm performance parameters and predictions.

BUR 10/2003. PL-2. Vegetation on the south slope of the disposal cell.
